Insitu Geotech Services Pty Ltd

PLANT HAZARD ASSESSMENT

“ESME” – All-Terrain In Situ Testing Rig

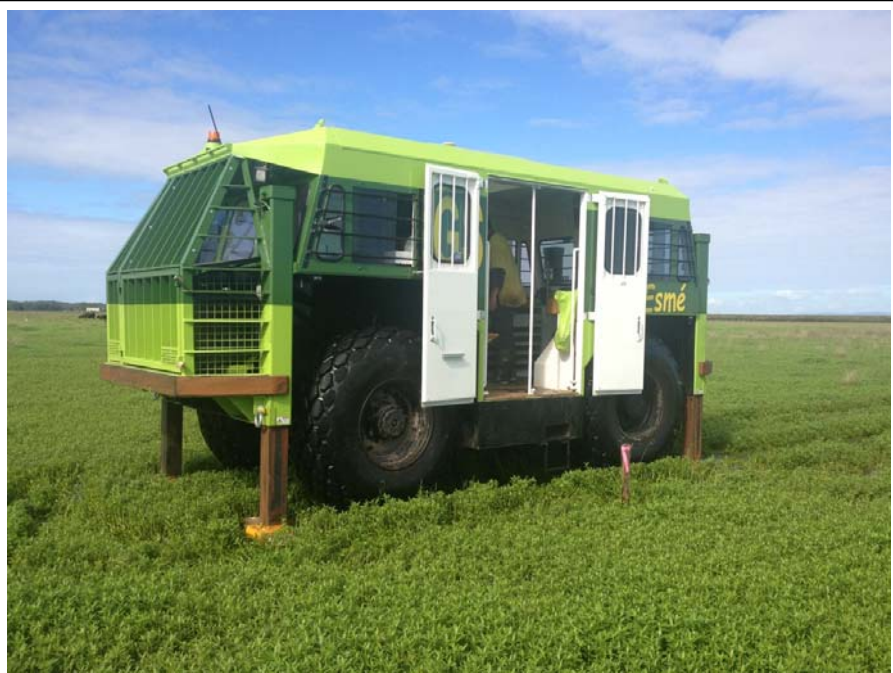
Diesel engine is mounted fully external to cabin (at end not visible in this photo). External mounting ensures quiet work space inside cabin and positive isolation from engine heat and exhaust fumes.
