Insitu Geotech Services Pty Ltd

# RIG RISK ASSESSMENT

RIG: "IGS01 ESME" – All-Terrain In Situ Testing Rig

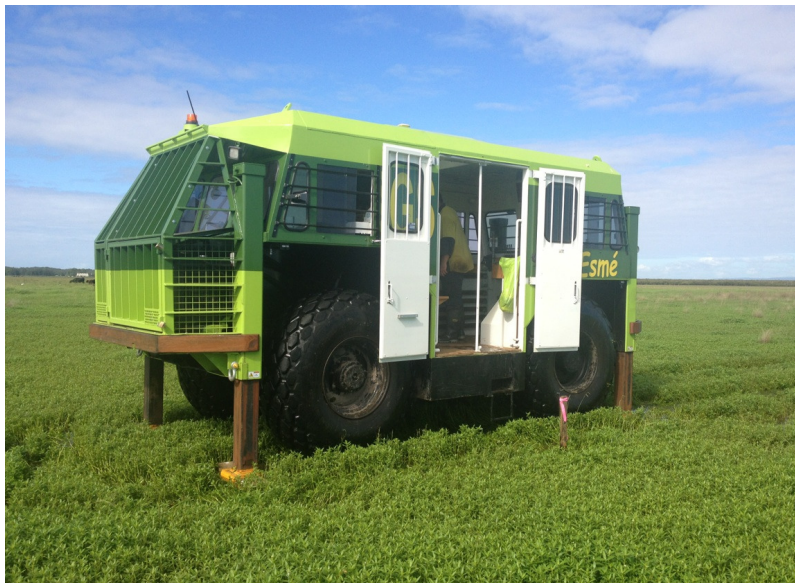
- All-terrain rig on balloon tyres
- Year Built: 2000 (refurb 2009)
- On-board broadband
- Differential GPS
- Mass 11-15t adjustable
- Push capability (up to 150kN)
- Test Types:
  - CPTu & Tee-Bar
  - DMT & SDMT
  - Vane Shear
- Also:
  - Piezometers
  - Standpipes
  - Vertek piston sampling
  - Eziprobe Sampling

Drive is fully hydraulic with radial piston motor on hub of each wheel. Tyre pressures are adjusted as required to suit terrain.

Two-speed drive - maximum travel speed is 3.2km/hr. Minimum speed unloaded is 1.6km/hr

Drive system automatically brakes in a fail-safe manner when not being driven.

Drive controls are by joy stick at each end of rig. Hence rig does not ever need to "reverse". Operator moves to appropriate end to drive rig forward at all relevant times. Joy sticks are isolated when not traversing

Joy sticks are deadman controls. If released, rig stops and brakes auto-apply.

Diesel engine is mounted fully external to cabin (at end not visible in this photo). External mounting ensures quiet work space inside cabin and positive isolation from engine heat and exhaust fumes.
